# CORAL 2.0 Technology Replication Thrust Forum Q4 2018

## Lessons Learned: Thru-Tubing Ceramic Screen Applications

30<sup>th</sup> November 2018  
Room 302-303, KL Convention Centre

Cheol Hwan Roh  
Sand Management SME  
Principal PT SKGRM  
PETRONAS Carigali Sdn Bhd

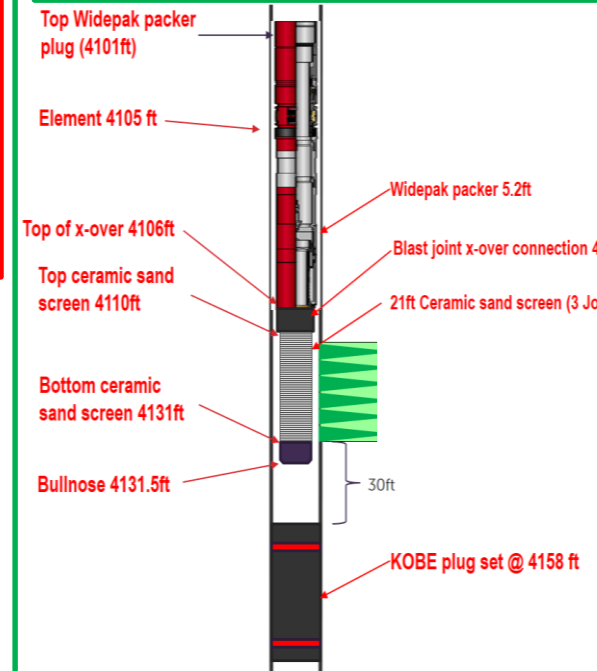
← 1<sup>st</sup> installation, Oct 2016 – Ceramic rings shattered due to Jarring during installation

2<sup>nd</sup> installation, Apr 2017

- No jarring. Battery timer set packer
- Still surviving to date Nov 2018 (20 mth). 215 bopd 145 bwpd 0.1 MMscfd in Oct 18

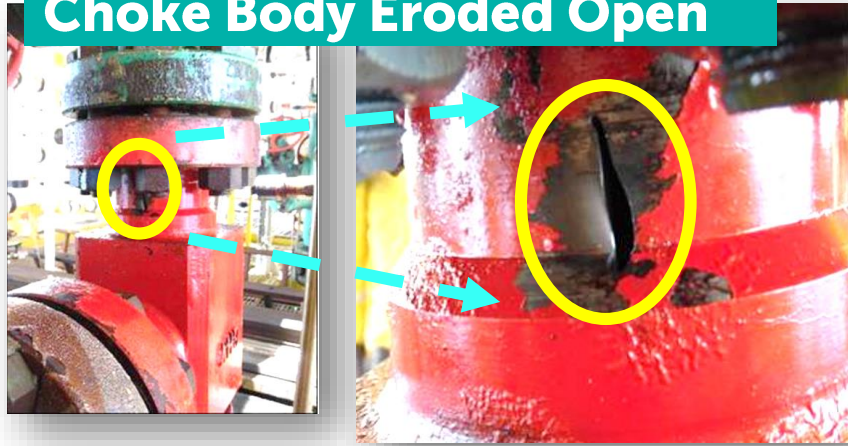
## Choke Body Eroded Open

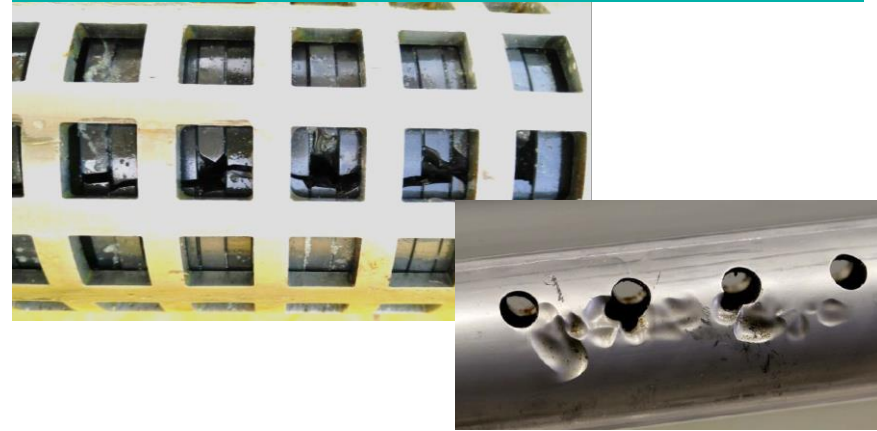
## Ceramic rings shattered

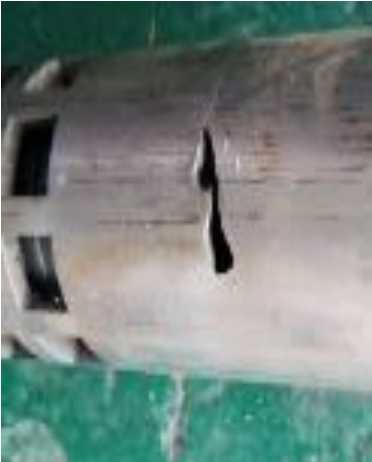
Hole on upper part of shroud

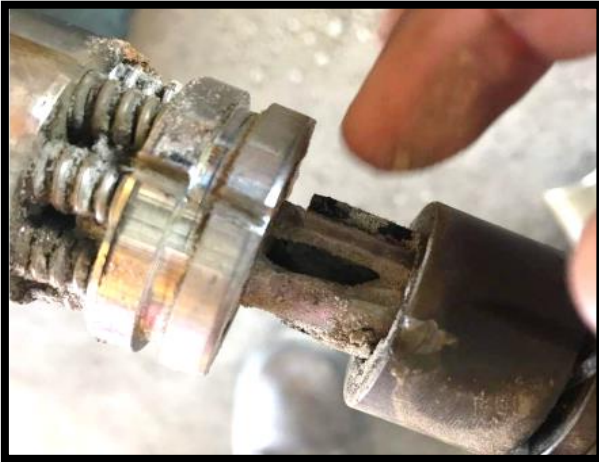
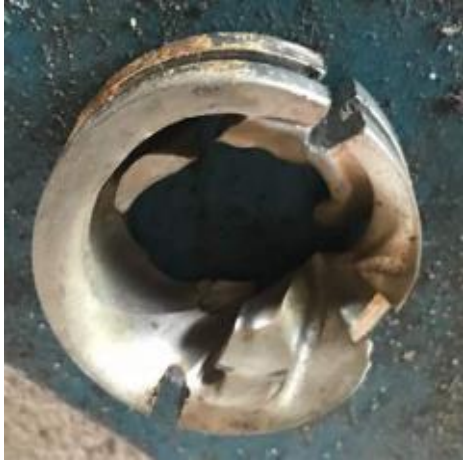
Base pipe erosion at spring compensator area

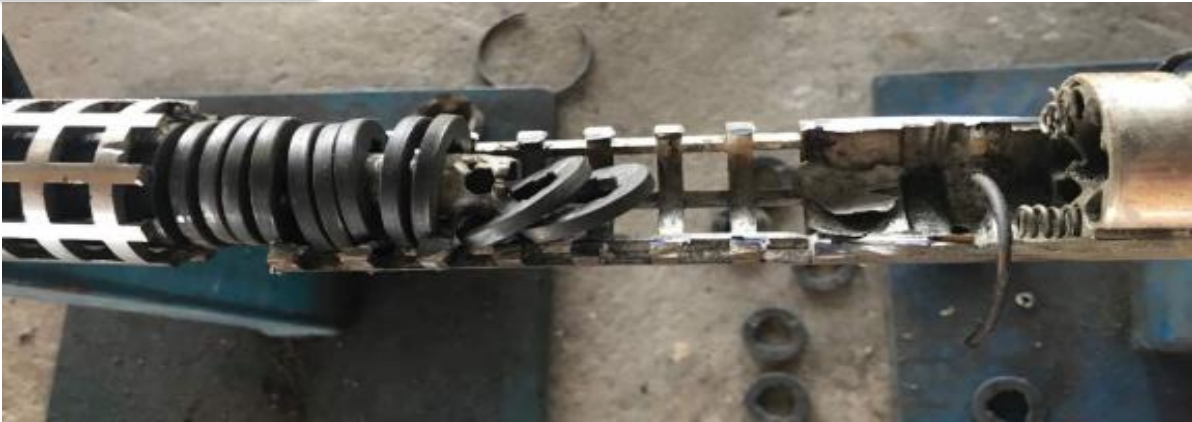
Metal seal ring badly eroded

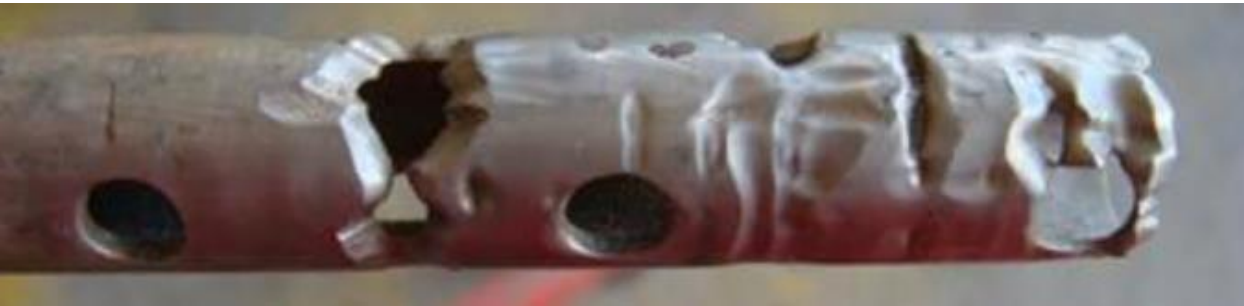
Sections of base pipe fully eroded away

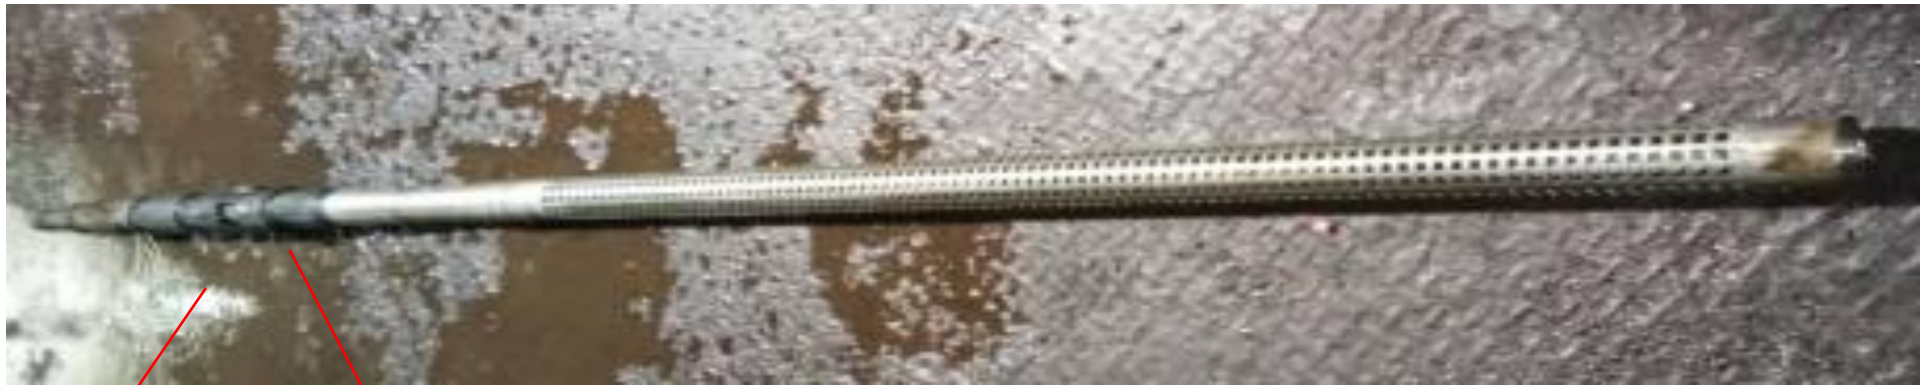
- Only a shroud of 1st jt retrieved. Fish – Basepipe & ceramic rings of 1st jt, entire 2nd & 3rd jts

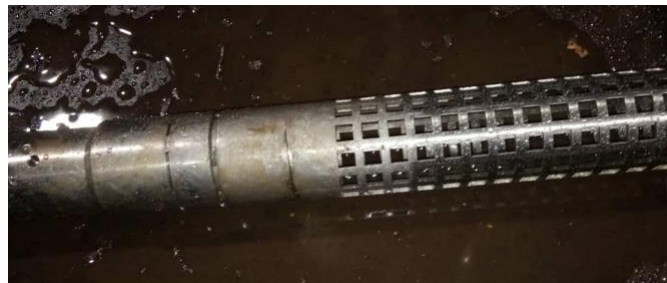
Empty shroud (base pipe & ceramic rings left in hole)

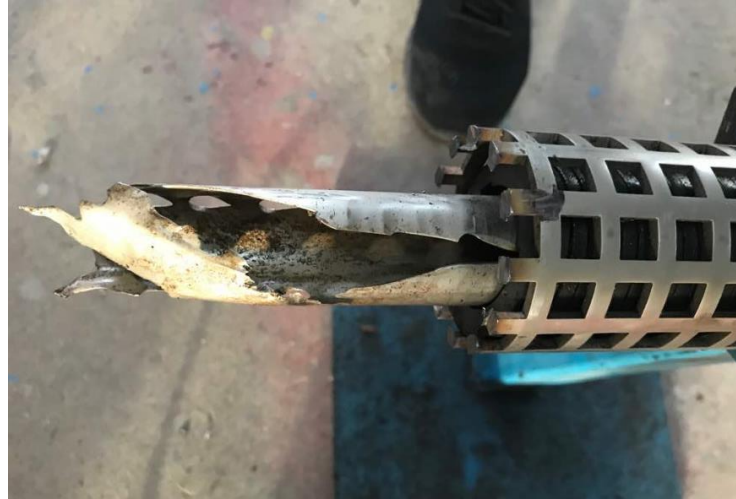
Base pipe almost fully eroded

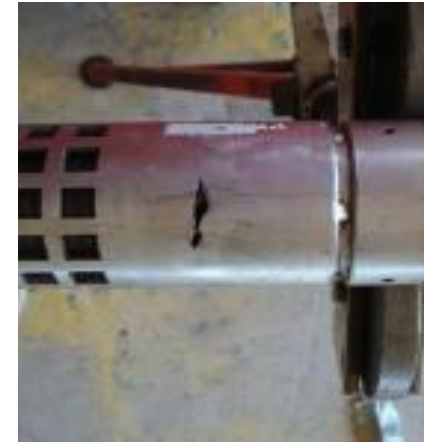
Erosion at box Module #3

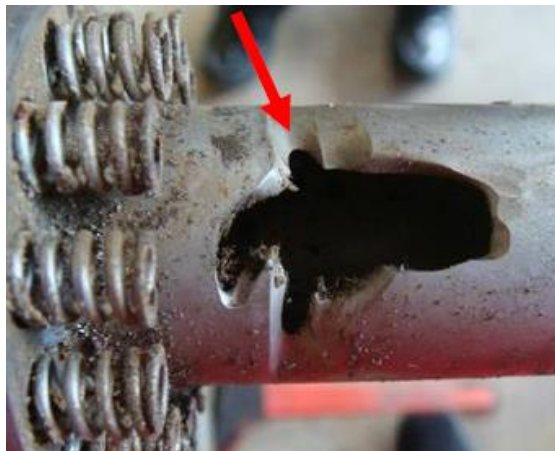
Chipped Ceramic

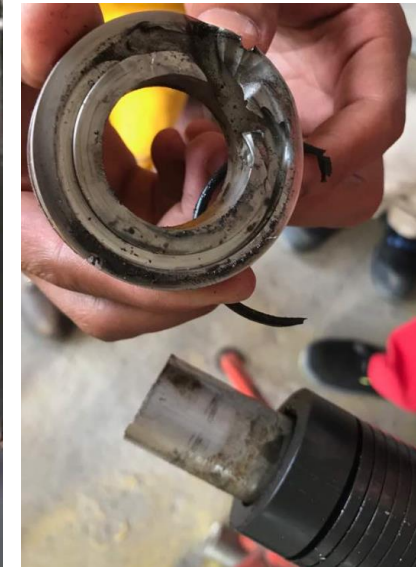
Metal seal ring badly eroded

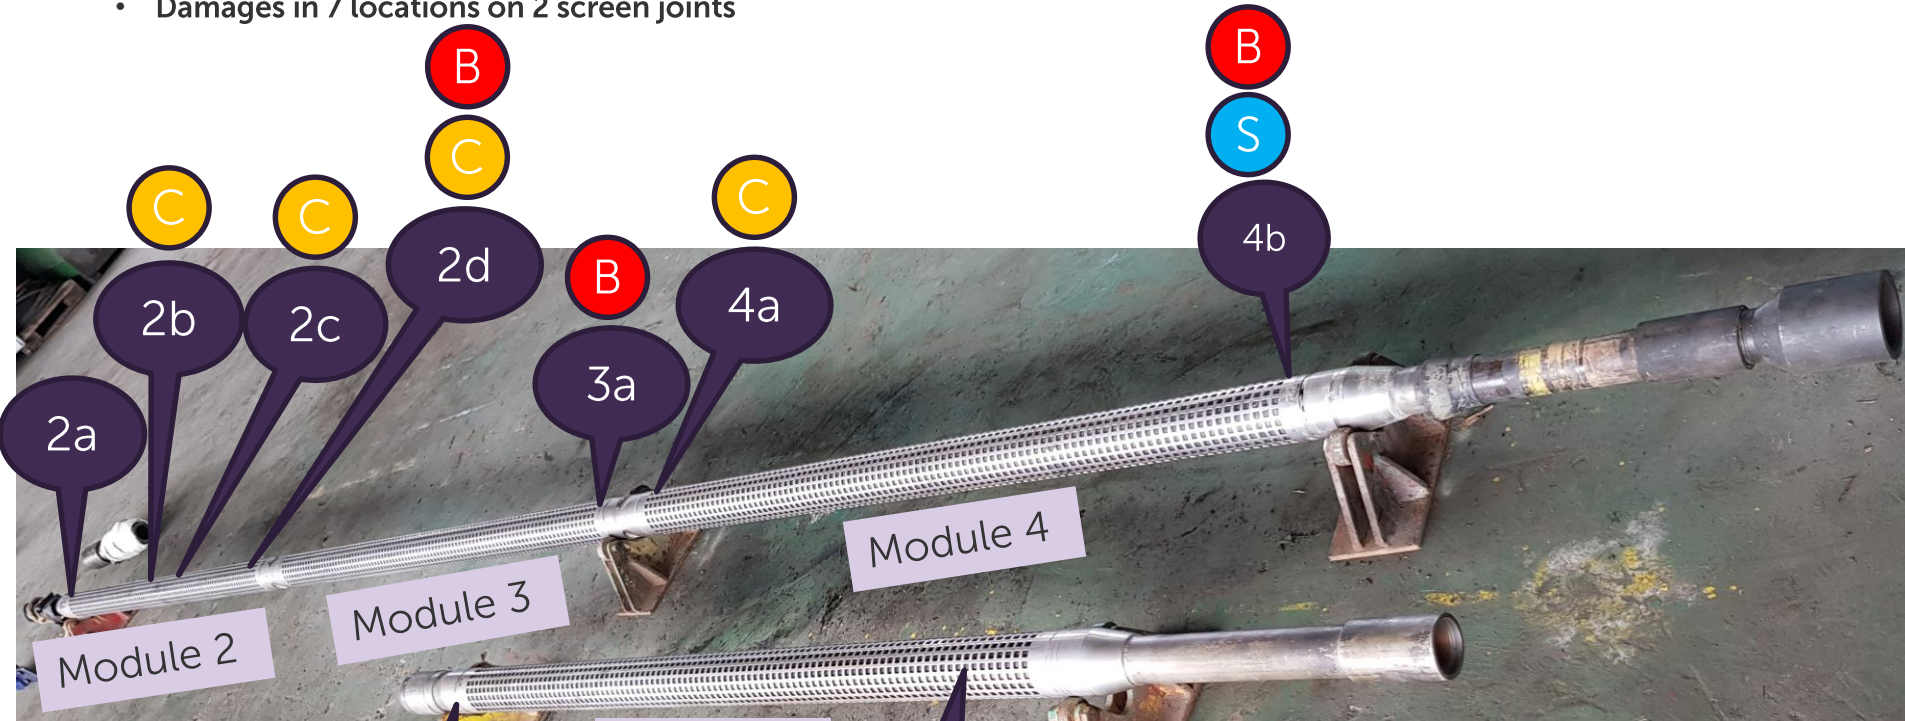
- Damages in 7 locations on 2 screen joints

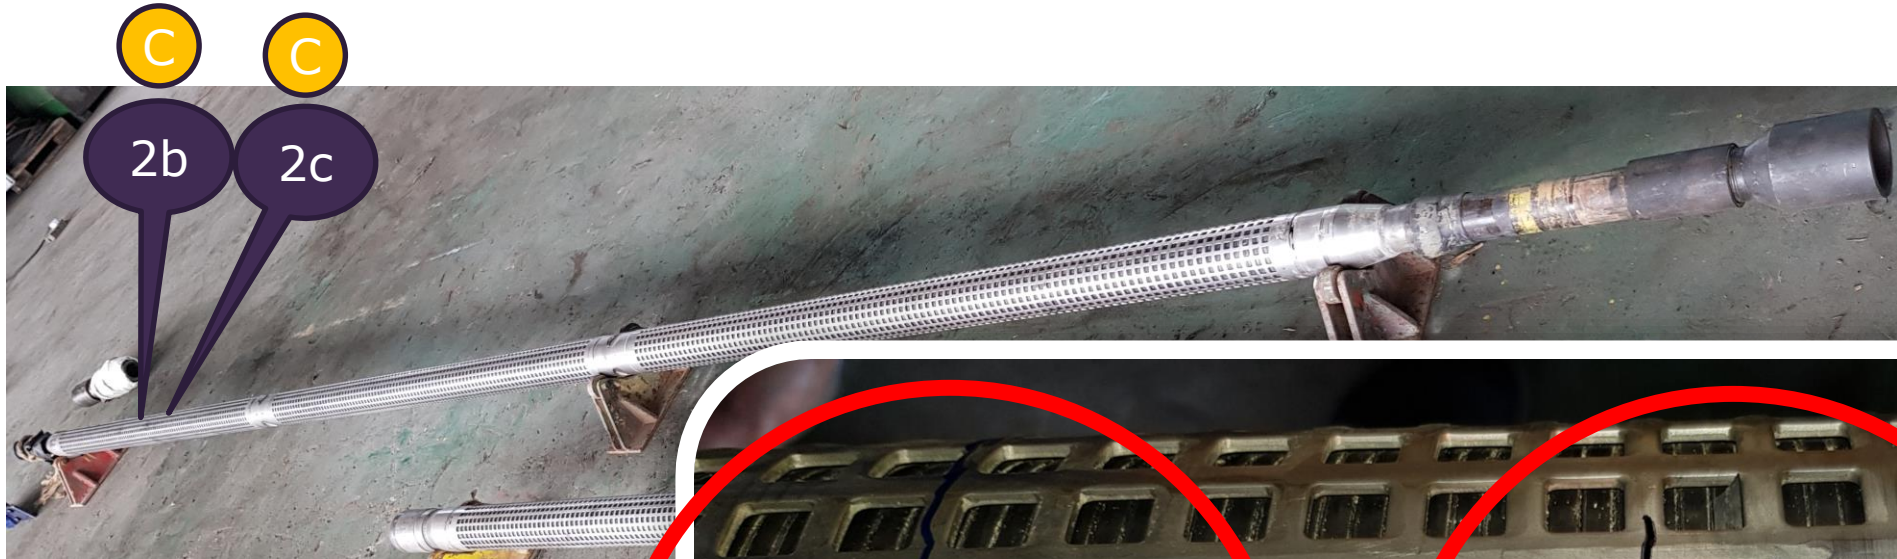
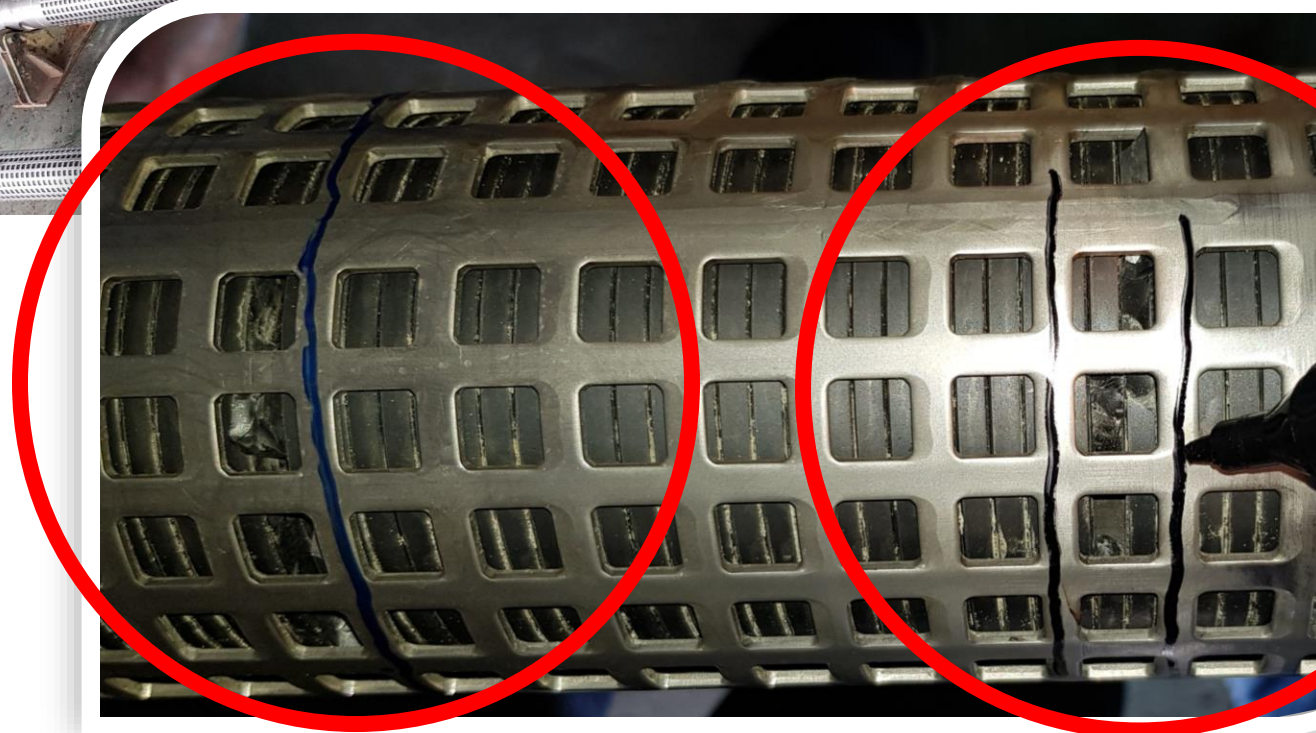
## Location #2b & 2c

- ceramic rings broken at 2 locations in the middle of module 2
- No major erosion on shroud. Only mild

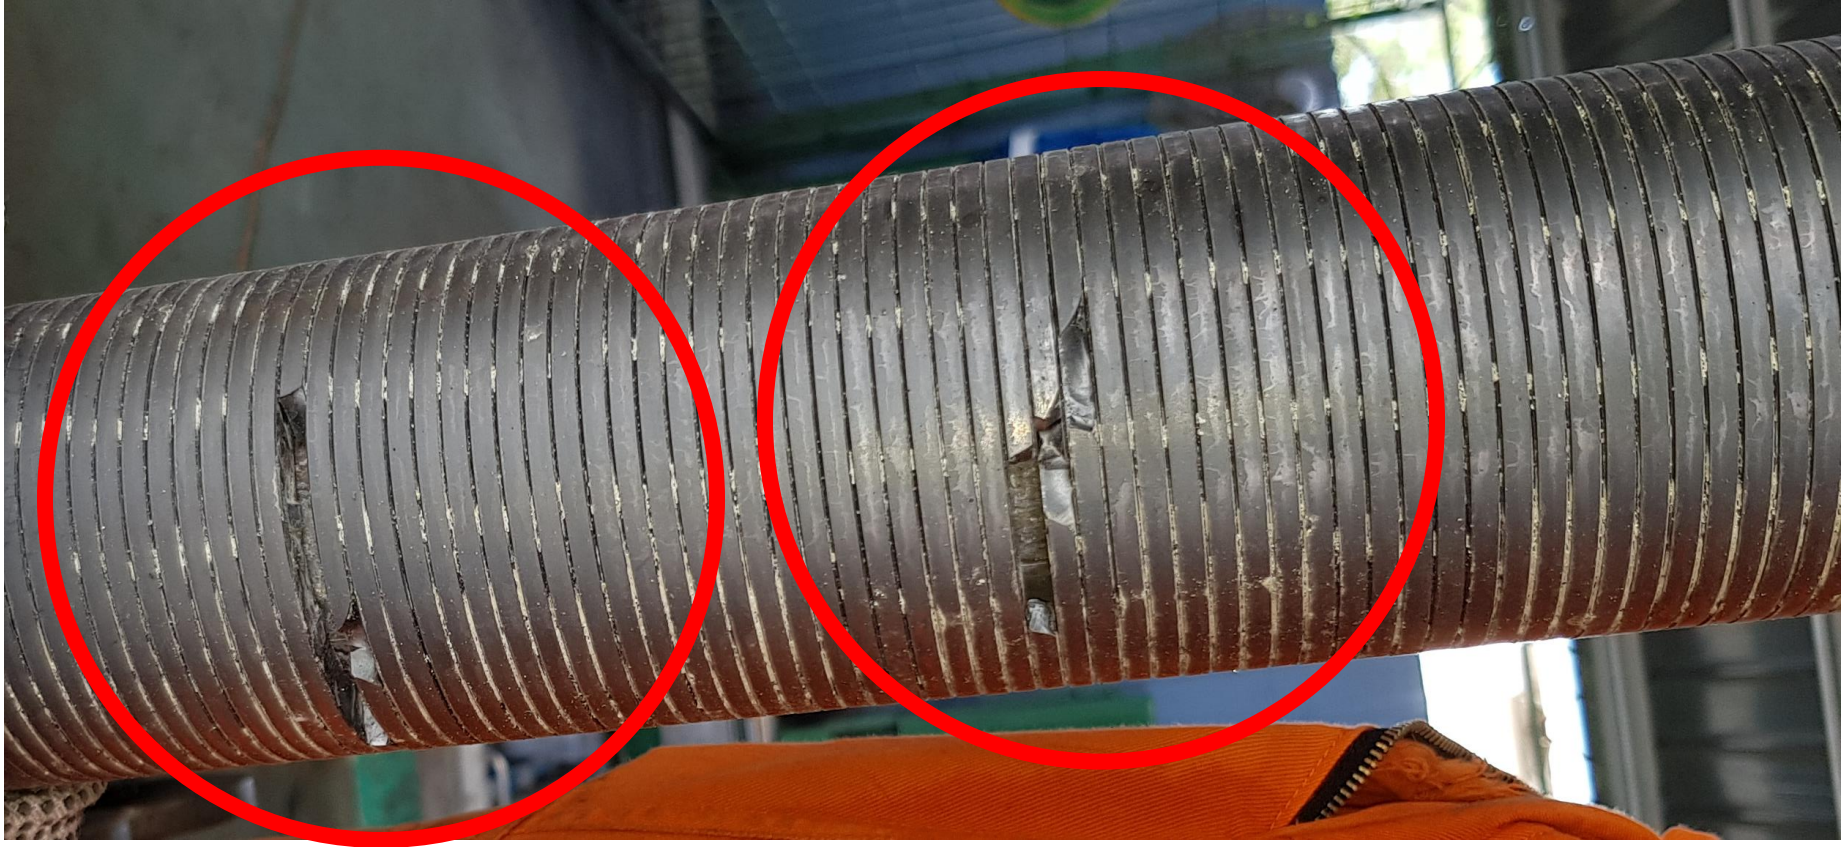
## Location #2b & 2c

- ceramic rings broken
- No major erosion on shroud. Only mild

Close up view after shroud is removed

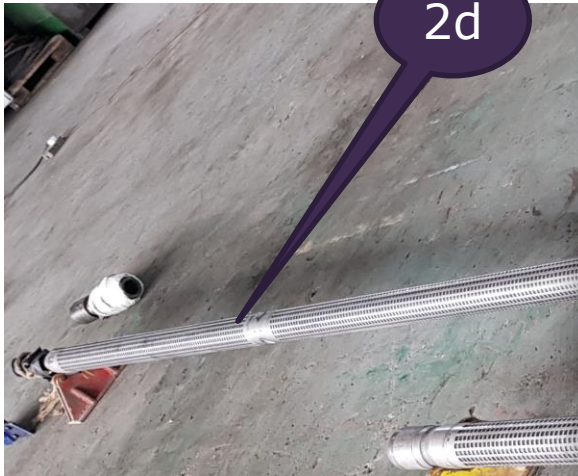
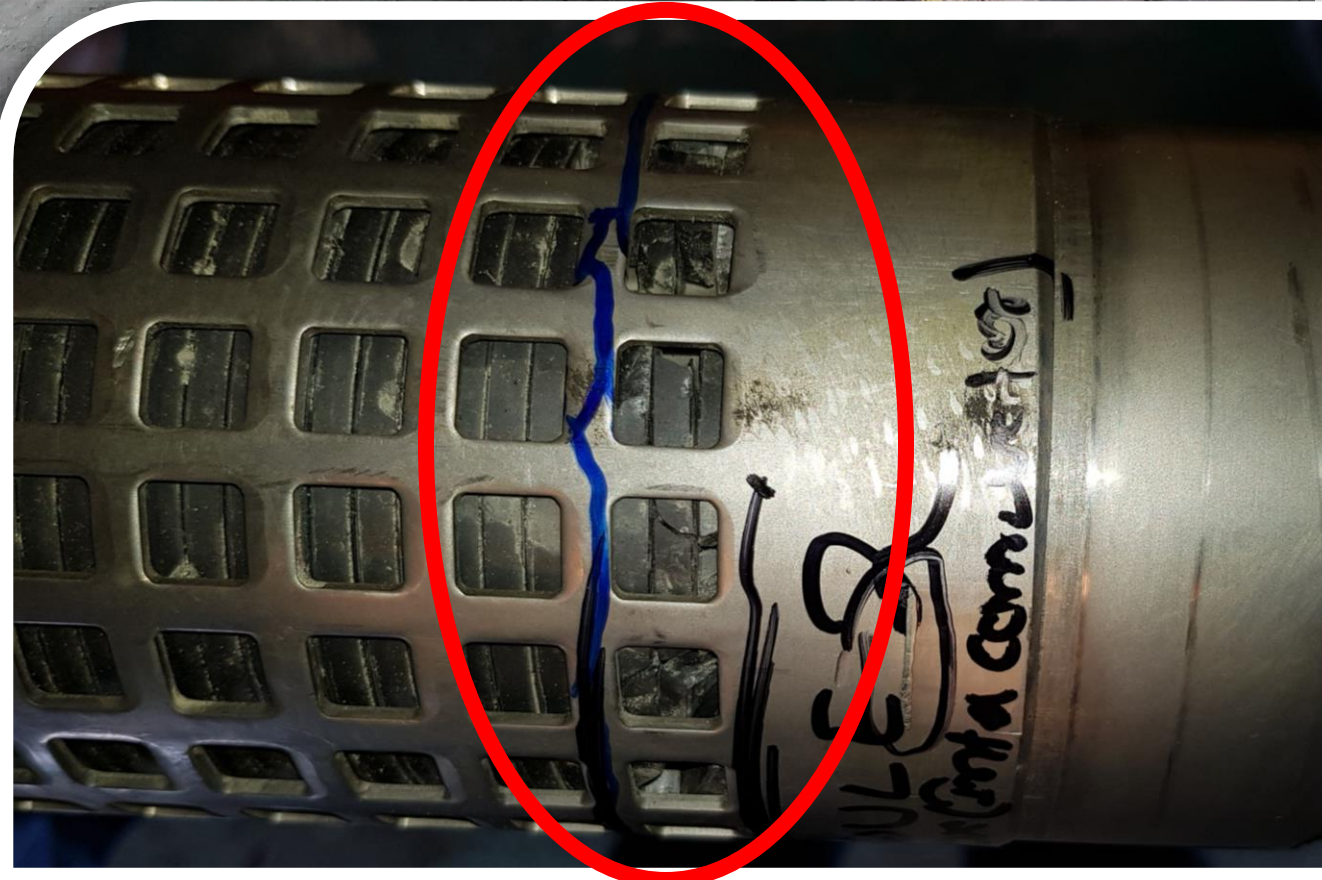
## Location #2d

- ceramic rings broken near upper end ring of module 2
- No major erosion on shroud. Only mild

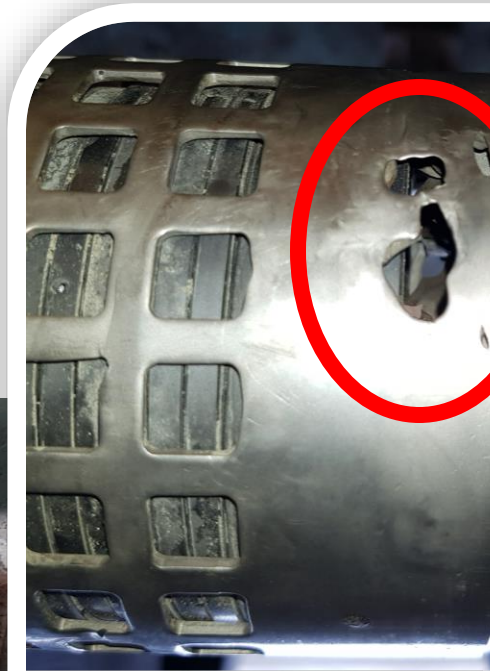
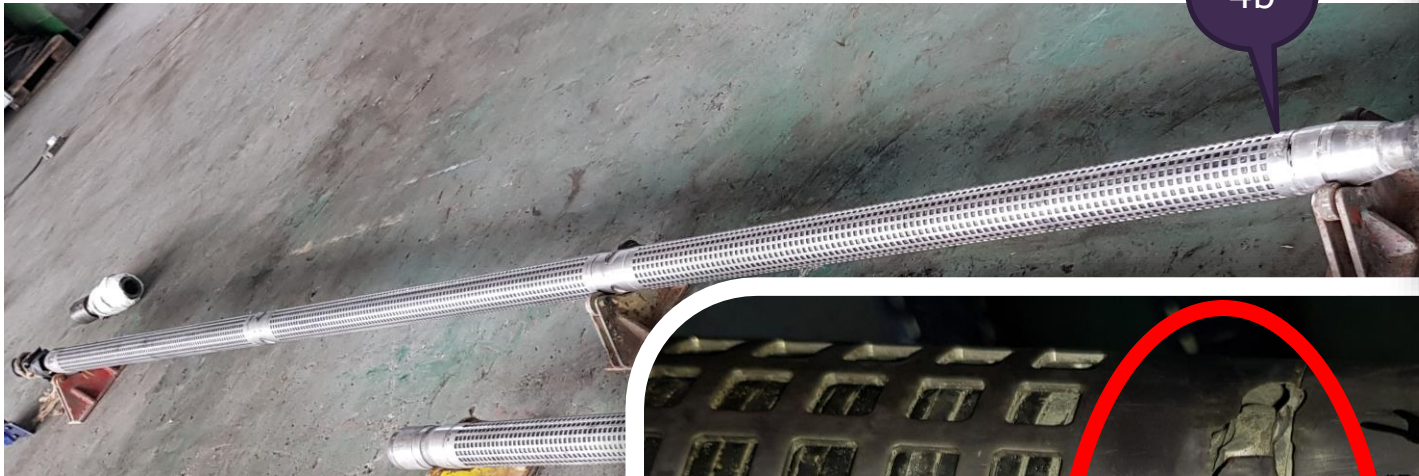
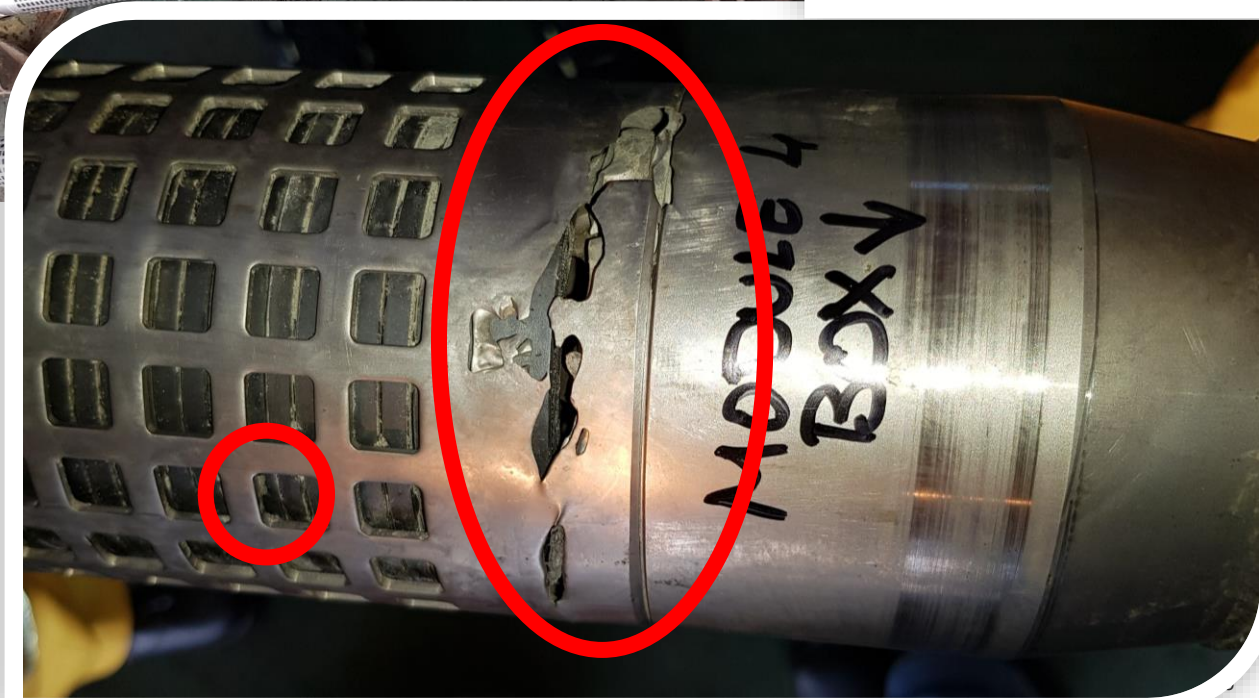
# Location #4b

- Blank portion of shroud severely eroded at multiple points all around near upper end ring of module 4
- Ceramic rings chipped near upper end ring

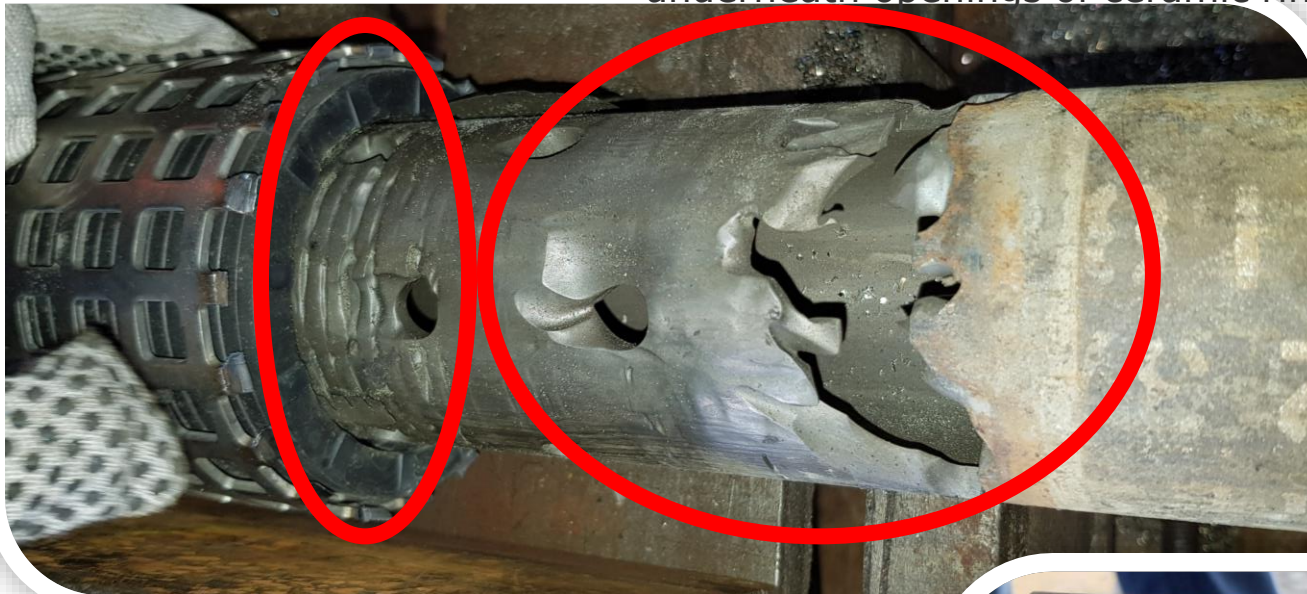
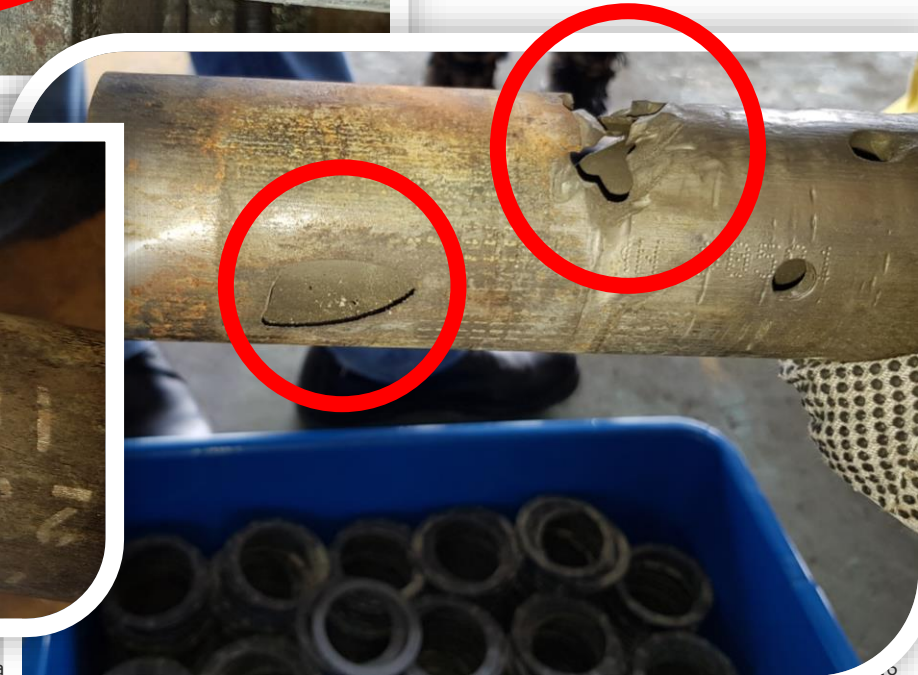
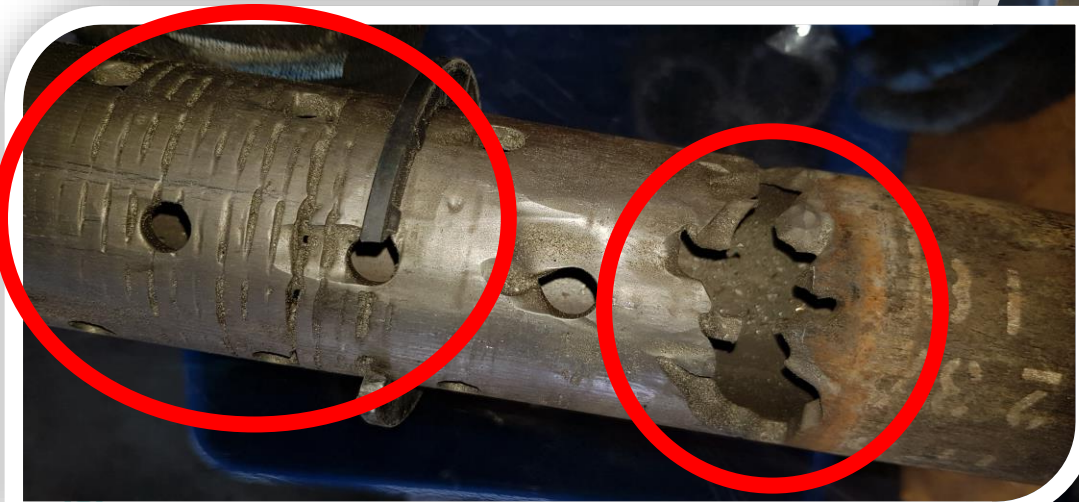
## Location #4b

- Severe erosion of base pipe underneath upper end ring of module 4. Material loss almost a half of pipe circumference.
- Circumferential grooves formed on base pipe due to erosion underneath openings of ceramic rings

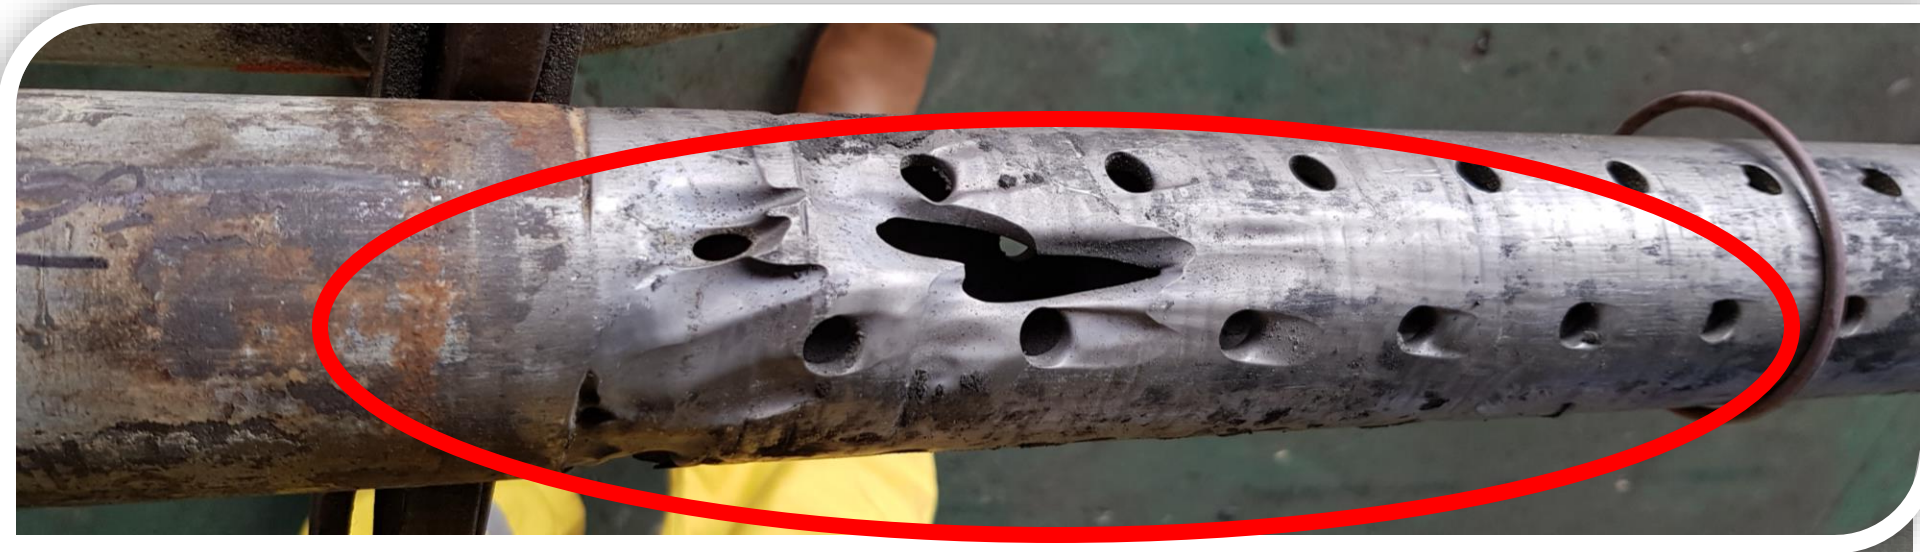
# Location #1a

Base pipe severely eroded near lower end ring of module 1

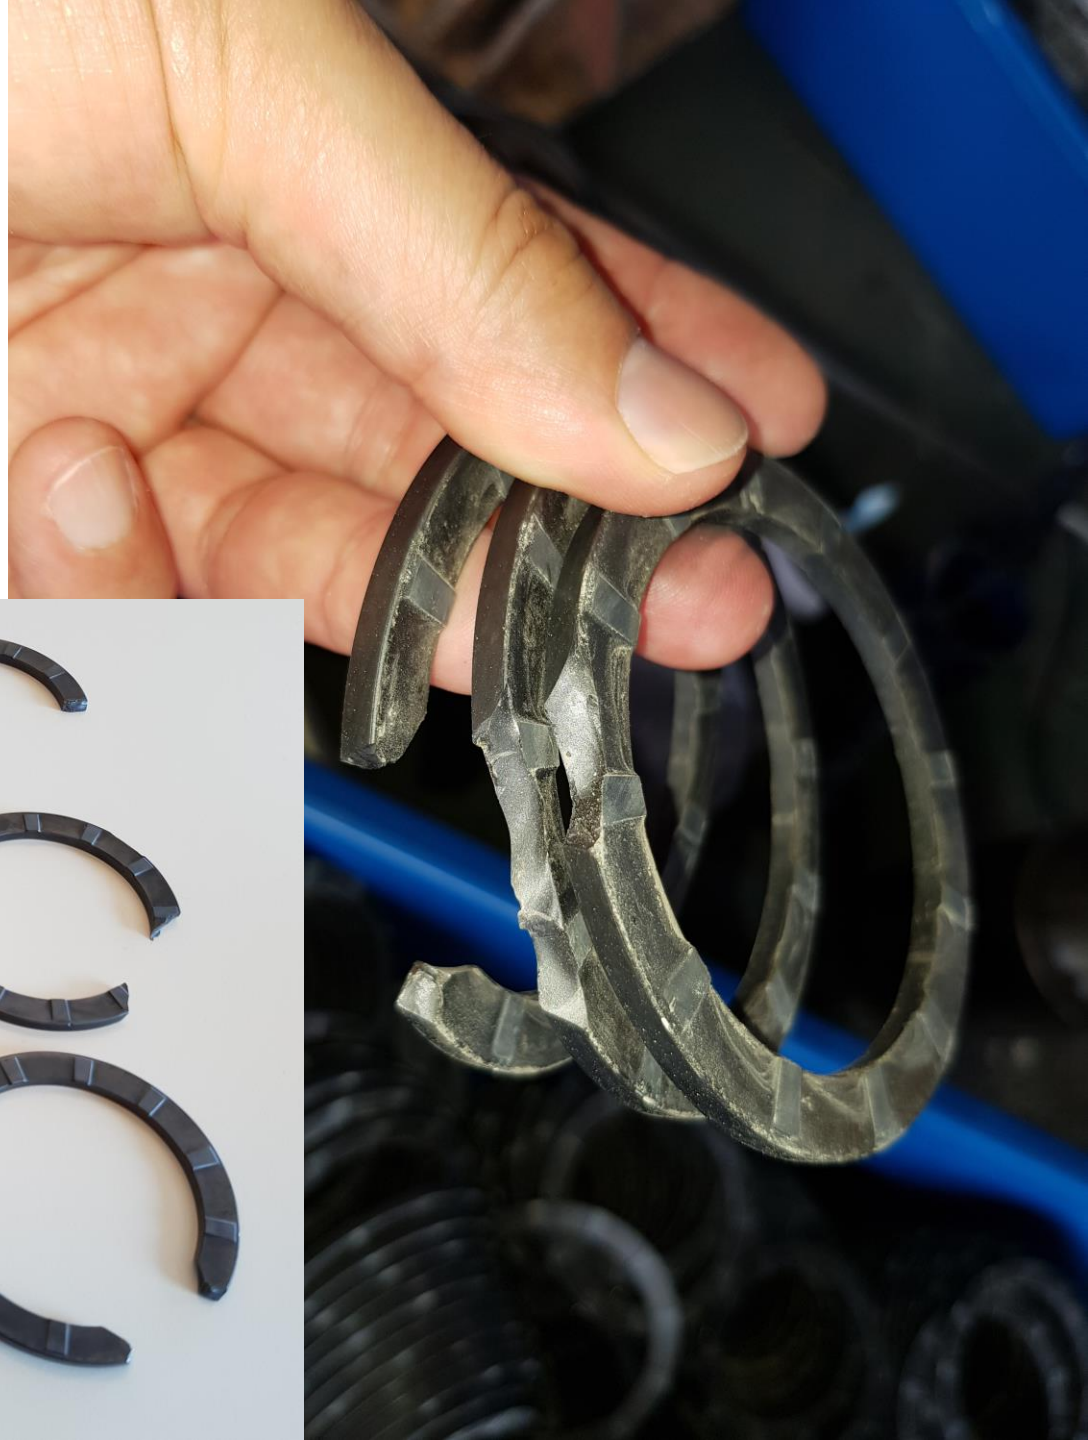
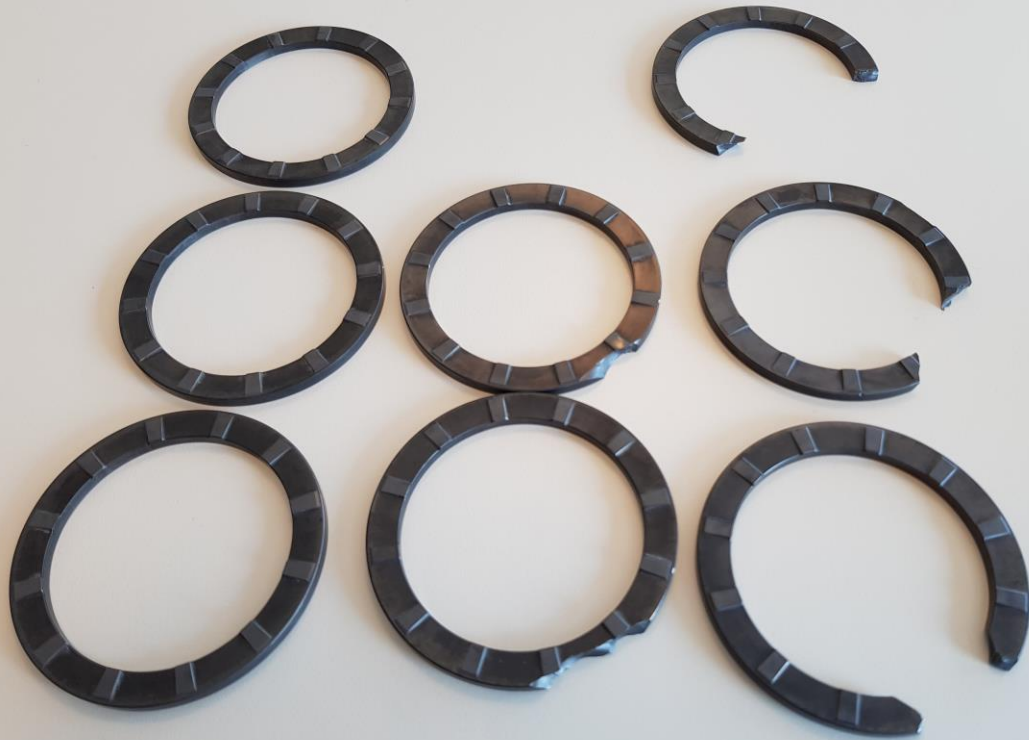
# Ceramic Rings Broken
