# CORAL 2.0 Technology Replication Thrust Forum Q4 2018

## Lessons Learned: Thru-Tubing Ceramic Screen Applications

30<sup>th</sup> November 2018  
Room 302-303, KL Convention Centre

Cheol Hwan Roh  
Sand Management SME  
Principal PT SKGRM  
PETRONAS Carigali Sdn Bhd

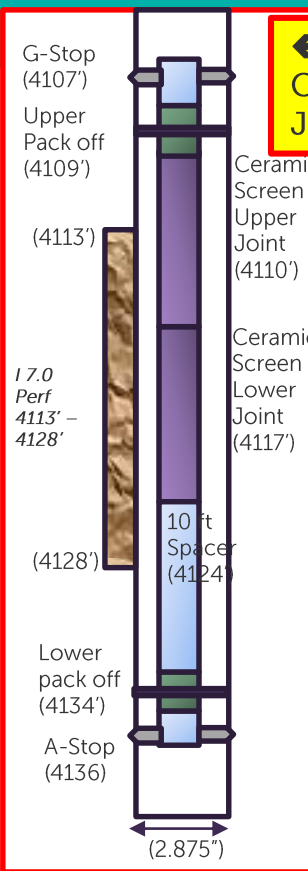
# Samarang F77L – Installed Ceramic Screen Twice

← 1<sup>st</sup> installation, Oct 2016 – Ceramic rings shattered due to Jarring during installation

2<sup>nd</sup> installation, Apr 2017

- No jarring. Battery timer set packer
- Still surviving to date Nov 2018 (20 mth). 215 bopd 145 bwpd 0.1 MMscfd in Oct 18

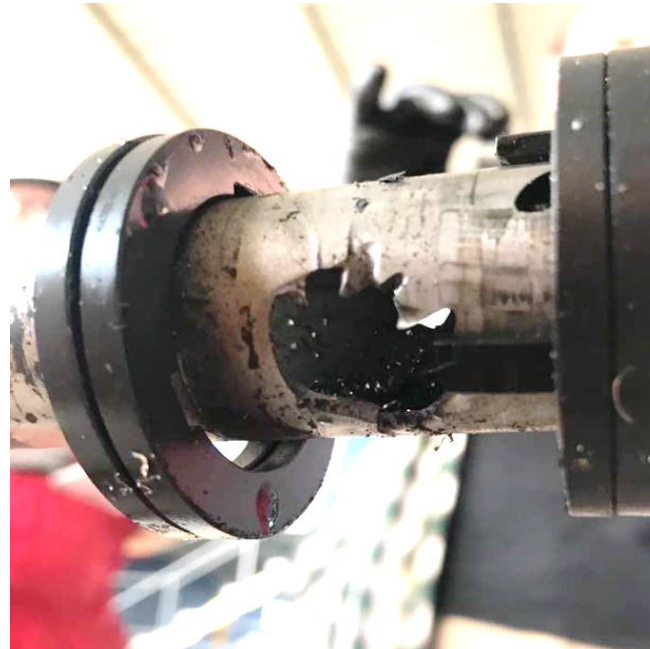
Metal seal ring badly eroded
